Subject: **CORRECTING VERTICAL SEAM IN
 SCREEN CENTER**

Model: **PVM-1942Q/1943MD/1944Q**

**THIS REVISION SUPERSEDES TECHNICAL
 BULLETIN 92-072 DATED JUNE 1, 1992**

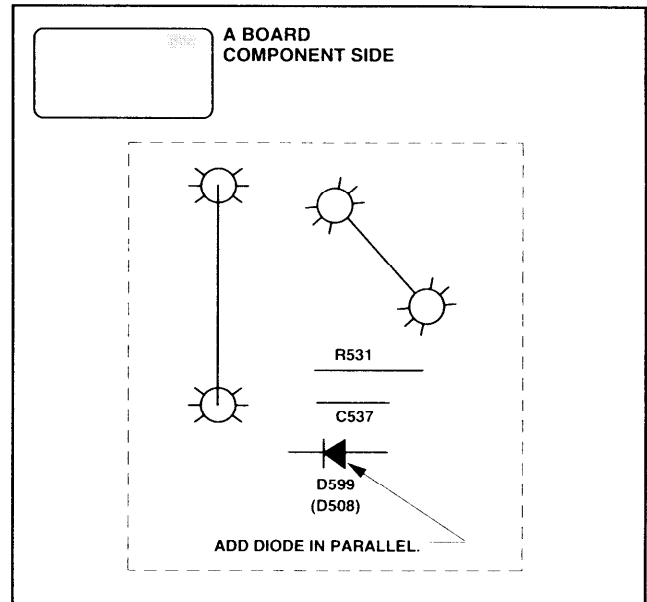
Figure 1

When receiving an all-white signal, or when screen contrast is high, a vertical seam may be visible in the center of the screen. To correct this condition, solder a diode in parallel to D599 on the A board (component side, zone B-1) as shown in Figure 1.

NOTE: On earlier units, D599 is marked as D508 and has the same pattern.
