Subject: **BATTERY COMPARTMENT PLATE**

Model: **PVM-8041Q**

Serial No: **2,000,500 AND LOWER**

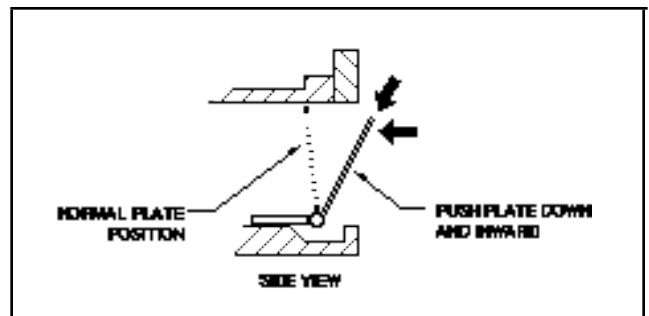
*Figure 1*

The battery compartment plate may sometimes protrude out of the compartment when the blue tape is removed. To correct this, push the plate down and inward as shown in Figure 1.
