Broadcast Products Technical Bulletin 20-2006-035

SUBJECT: **POWER SUPPLY SHUTS DOWN MOMENTARILY**

MODEL: **BVM-D9H1A**
BVM-D9H1E
BVM-D9H1U
BVM-D9H5A
BVM-D9H5E
BVM-D9H5U

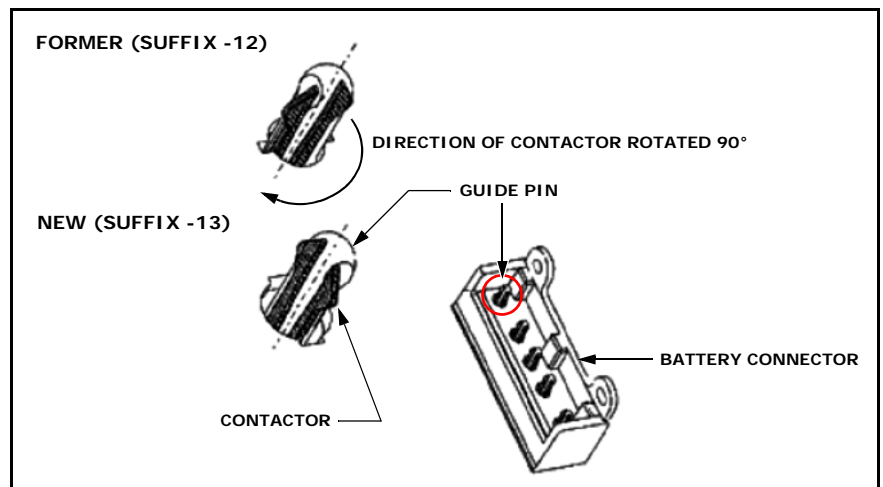
Figure 1

NOTE: The new battery connector is shaped differently and the contactor on the guide pin is rotated 90°. (See Figure 1.)

Replace the battery connector (1-766-377-12) with a new battery connector (1-766-377-13).
