## Display

Subject: **VERTICAL SEAM IN CENTER OF DISPLAY**

Model: **PVM-1942Q/1944Q**

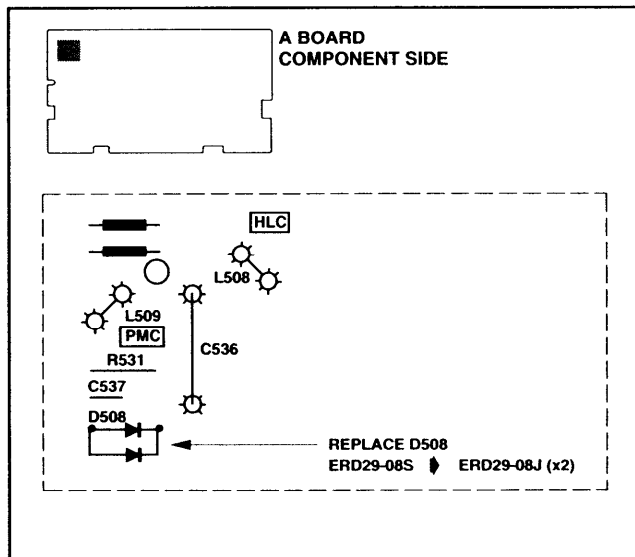
Figure 1

A vertical seam may sometimes appear in the center of the screen when an all-white pattern is displayed. To correct this, modify the A board as described below.

1. Remove D508 (zone B-1). If there is an ERD28-08S diode mounted in parallel to D508 on the solder side of the board, remove it also.
2. Solder two ERD29-08J diodes in parallel, and mount them in place of D508.
