Broadcast Products Technical Bulletin 20-2004-106

SUBJECT: NO RED OR BLUE COLOR ON SCREEN

MODEL: ***BVM-D9H1A***
BVM-D9H1E
BVM-D9H1U
BVM-D9H5A
BVM-D9H5E
BVM-D9H5U

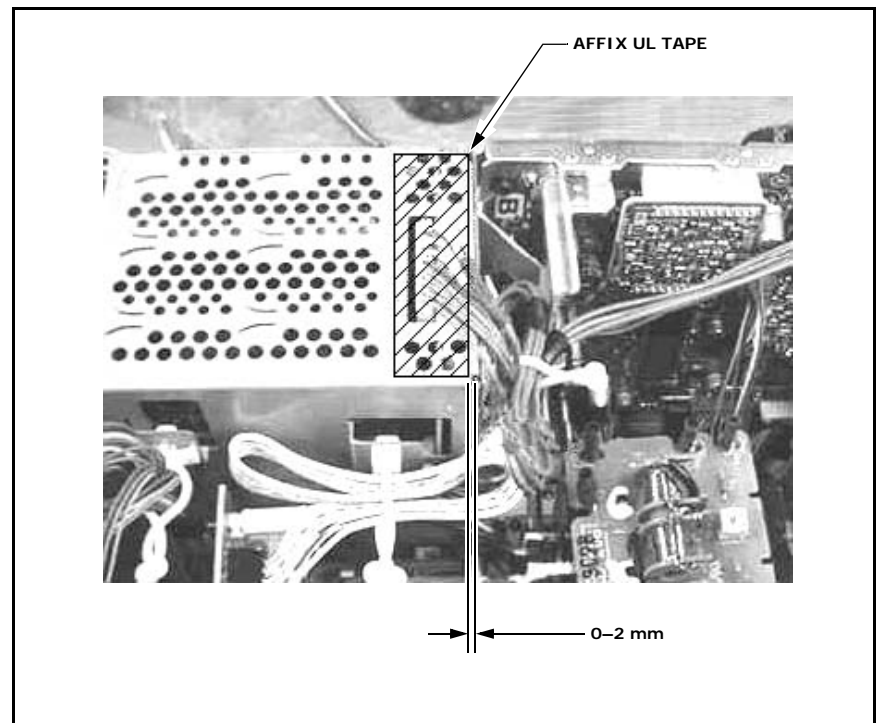
Figure 1

Red or blue color may not appear on the screen.

This symptom occurs if the harness from CN801 on the T board is positioned inappropriately and becomes pinched or damaged by the top cover when closed.

UL tape, 19 mm × 70 mm

To protect the harness from the edges of the ventilation holes on the top cover, affix UL tape as shown in Figure 1.

NOTE: Ensure that the tape does not overlap the top edge of the cover.
