Video Products Technical Bulletin 30-2002-168

DATE: **September 16, 2002**SUBJECT: **HOLES FOR ACCESSORY INSTALLATION
LOCATED INCORRECTLY**MODEL: ***BVM-D9H1E***
BVM-D9H1U

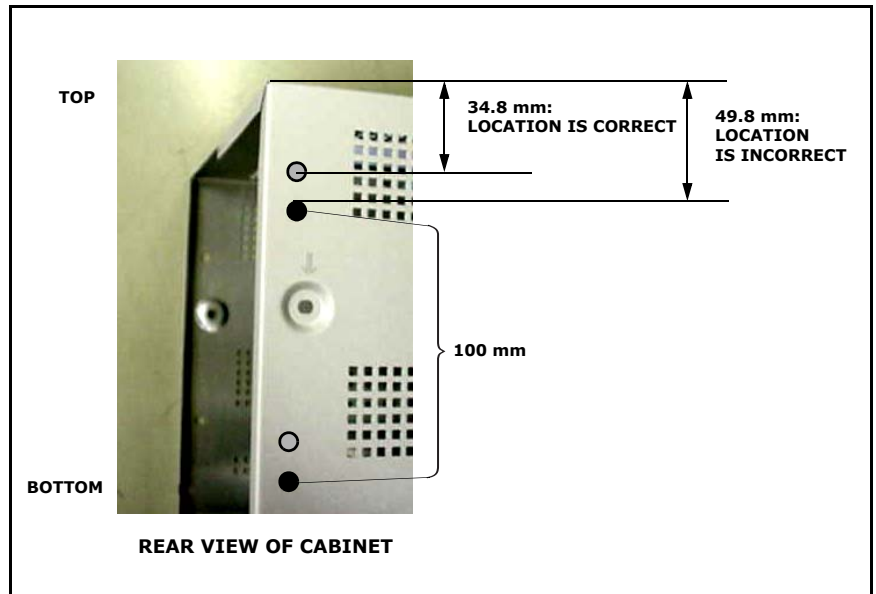
Figure 1

Measure the distance between the top of the cabinet and the center of the first hole.

If the distance is:

- 34.8 mm: Location of the holes is correct.
- 49.8 mm: Location of the holes is incorrect.

- The cell spacer (nut) can be seen through the hole when located incorrectly.
- There are four holes (5.5 mm) for installation of accessories.

The holes for installing accessories may be located incorrectly. As a result, when a VF-508 (monitor ENG kit) is installed, and the monitor is placed on a flat surface, the unit slants forward and the rear is raised approximately 15 mm.

Confirm the location of the holes. If the location is incorrect, perform the modification procedure.
