Video Products Technical Bulletin 94-139

Date: December 12, 1994 Subject: MANUAL CORRECTION—C811 PART

Model: PVM-91

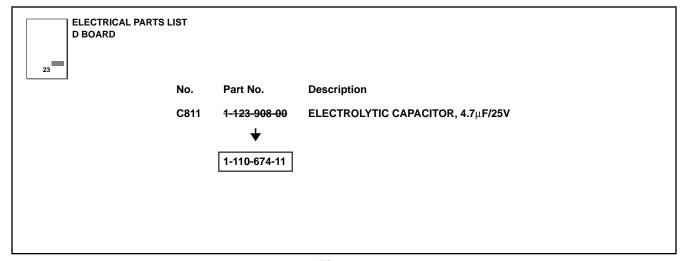
Figure 1

Correct the PVM-91 Service Manual as shown in Figure 1. When replacing C811 on the D board, use a capacitor with the correct part number.
