Repair Document For Known Sony PVM CRT Issue

Published by S13G32

PVM-1353MD/1453MD

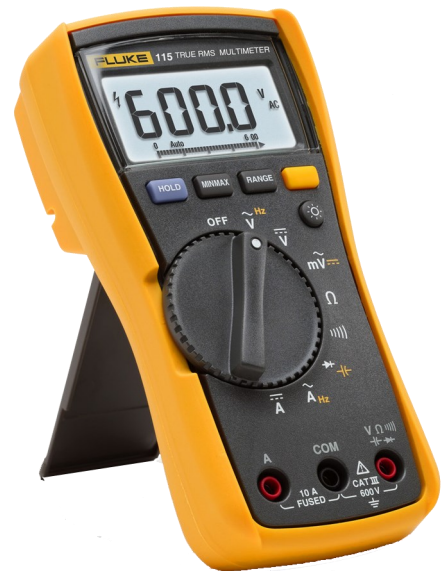
Fluke 115 Multimeter

After replacing all the caps on my G board for both my 1352MD and 1351Q models I was still getting the failure. I went through and checked all the caps again with my Woods multimeter which has served me well for years now. I urge you to use an electronic multimeter for this repair due to being easier to read outputs off the G board and the more options you will typically get from it. A fluke meter was my weapon of choice and did a great job of reading all the power rails that I needed it to.
