Date: **March 9, 1998**

Subject: **MOMENTARY HORIZONTAL NOISE**

Model: **PVM-8040, PVM-8041Q, PVM-8044Q**
PVM-8043MD, BVM-8044QD

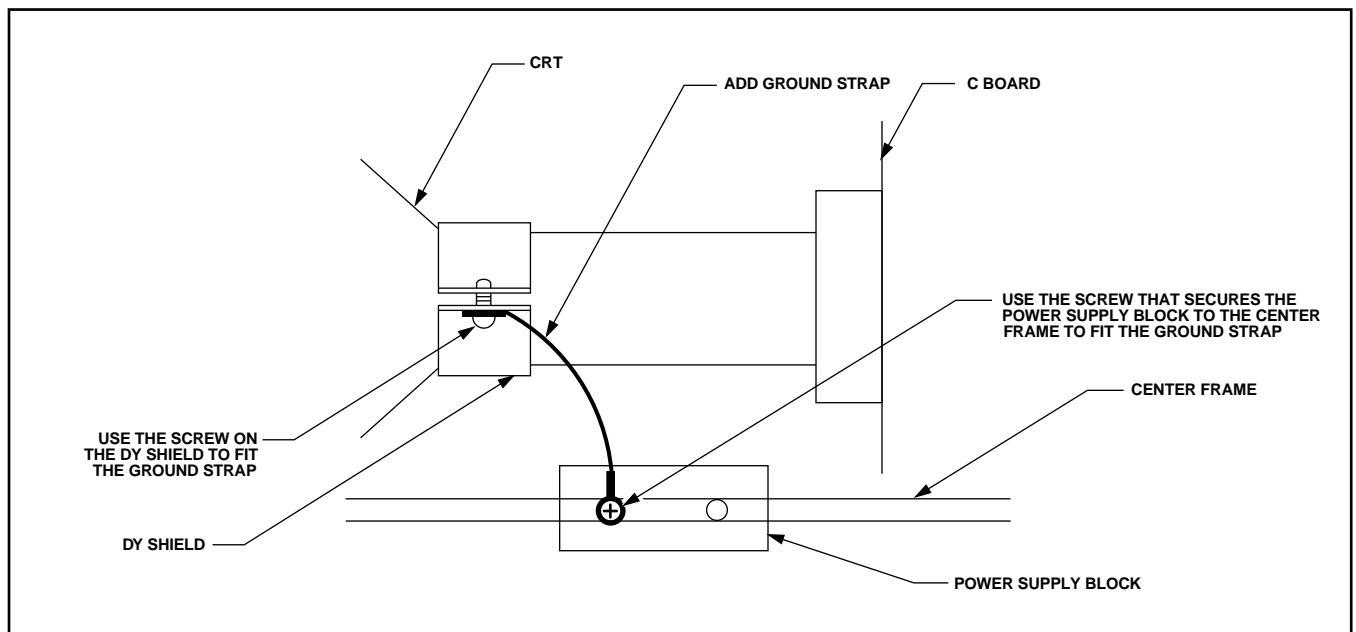
Figure 1

Static electricity on the DY shield may cause horizontal noise to be displayed. To correct this condition perform the following modification.

Fit a ground strap between the DY shield and the center frame as shown in Figure 1.
