Date: **June 5, 2000**

Model: **BVM-D20F1E, BVM-D20F1U
 BVM-D24E1WE, BVM-D24E1WU**

Subject: **PICTURE TRIMMED AT TOP
 OR LEFT EDGE**

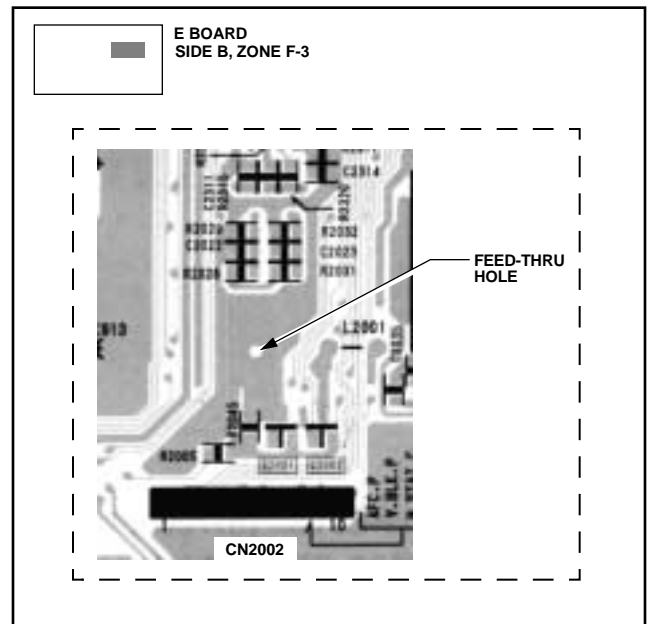
Figure 1

Part of the picture may not be displayed at the top or left edge of the monitor even if blanking width is minimized. To correct the symptom, perform the following modification procedure.

1. On IC2006, cut trace between pin 4 and GND.
 Drill feed-thru hole to cut trace between IC2006 pin 4 (side A, zone F-3) and GND (side B, zone F-3). (See Figure 1.)
2. Solder jumper between IC2006 pin 4 and -12V bus. (See Figure 2.)
