**Display**

Subject: **CORRECTING AUDIO JACK DEFORMATION**

Model: **PVM-8040/8041Q/8044Q**

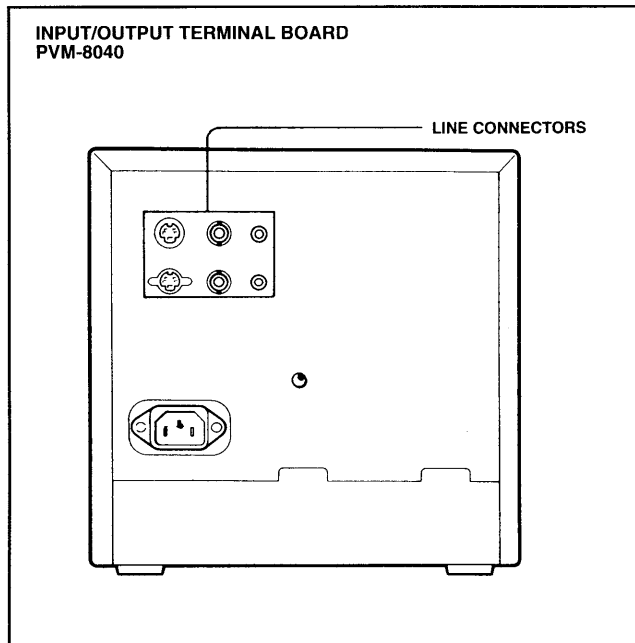
**Figure 1**

The insulating material for the audio jack on the Input-Output Terminal board may have become slightly deformed by the heat generated during production. In extreme cases, it may become difficult or impossible to insert the audio pin into the audio jack. To correct this problem, new Input-Output Terminal boards for line A and line B connectors are now available. (See Figures 1 and 2.) The new part numbers are as follows.

- PVM-8040  
 Input-Output Terminal Board  
 1-537-411-11
- PVM-8041Q/8044Q  
 Input-Output Terminal Board (Line A)  
 1-537-410-11

Input-Output Terminal Board (Line B)  
 1-537-408-11
