Video Products Technical Bulletin 30-2004-032

SUBJECT: **NO PICTURE FROM DAMAGE TO Q613 ON G BOARD**

MODEL: ***BVM-D14H1A***
BVM-D14H1E
BVM-D14H1U
BVM-D14H5A
BVM-D14H5E
BVM-D14H5U

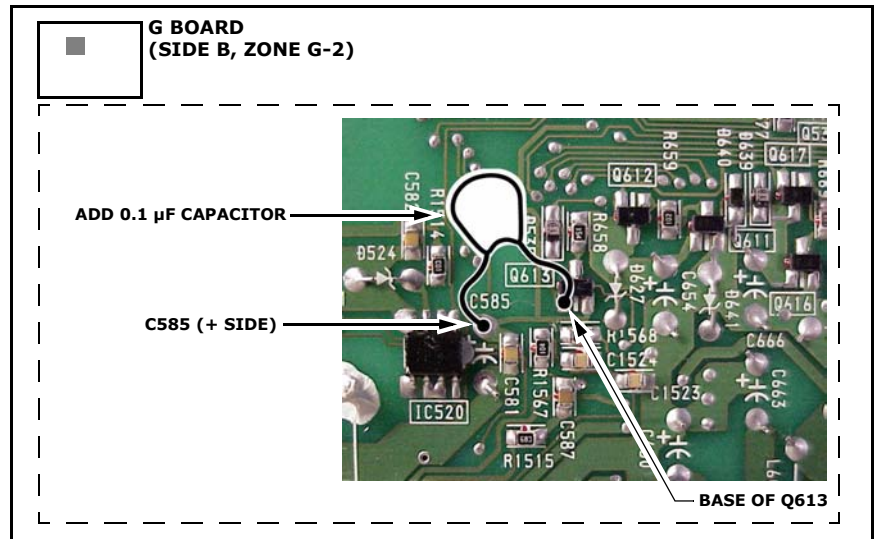
Figure 1

The picture may disappear if Q613 on the G board is damaged and the protection circuit operates.

G Board (Side B, Zone G-2)

1. Solder a 0.1 μ F capacitor between the base of Q613 and the positive (+) side of C585. (See Figure 1.)
2. Affix the capacitor to the board with bond.
