Display

Subject: **NOISE IN PICTURE**

Model: **BVM-D14H1E, BVM-D14H1U,
 BVM-D14H5E, BVM-D14H5U**

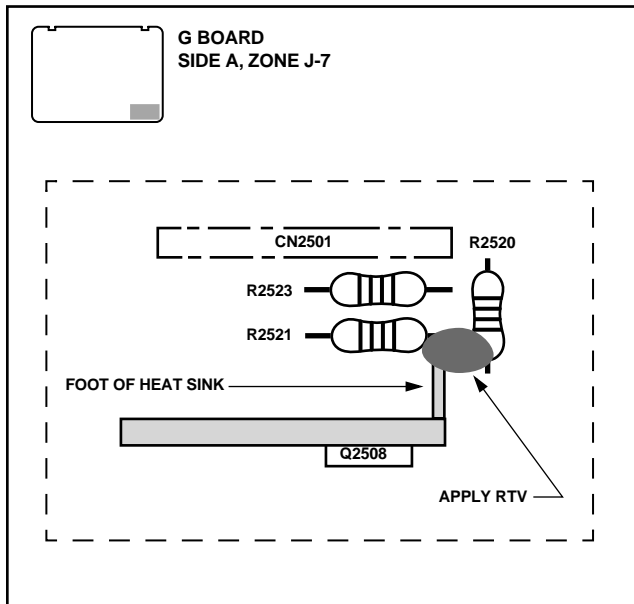
Figure 1

If the unit receives an excessive physical shock, R2521 on the G board may touch the Q2508 heat sink located nearby, resulting in noise in the picture.

G Board (Side A, Zone J-7)

1. Verify that R2521 sits straight up.
2. Apply RTV between R2521 and the heat sink.
