Date: **January 10, 2000**

Subject: **FLASHING PICTURE OR IRREGULAR  
 WHITE BALANCE**

Model: **BVM-8044QD, PVM-5041Q, PVM-8040  
 PVM-8041Q, PVM-8043MD, PVM-8044Q**

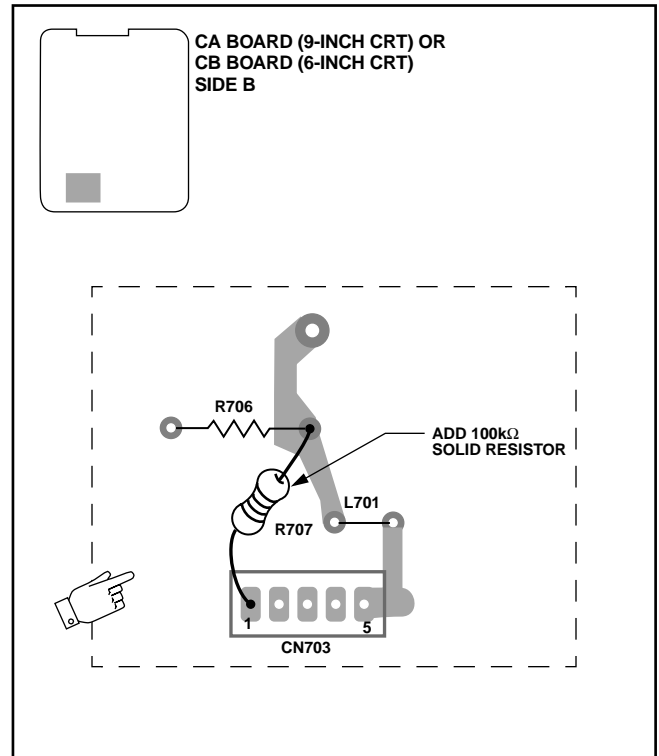
**Figure 1**

In some units, the picture may flash or white balance may become irregular. If this occurs, perform the following procedure.

**CA Board (9-inch CRT) or CB Board (6-inch CRT)  
 Side B (See Figure 1.)**

1. Replace CRT.
2. Solder new 100kΩ solid resistor as shown.
