CLD-A100

SERVICE INFORMATION

No. : SI-V48056

CLD-A100 LaserActive

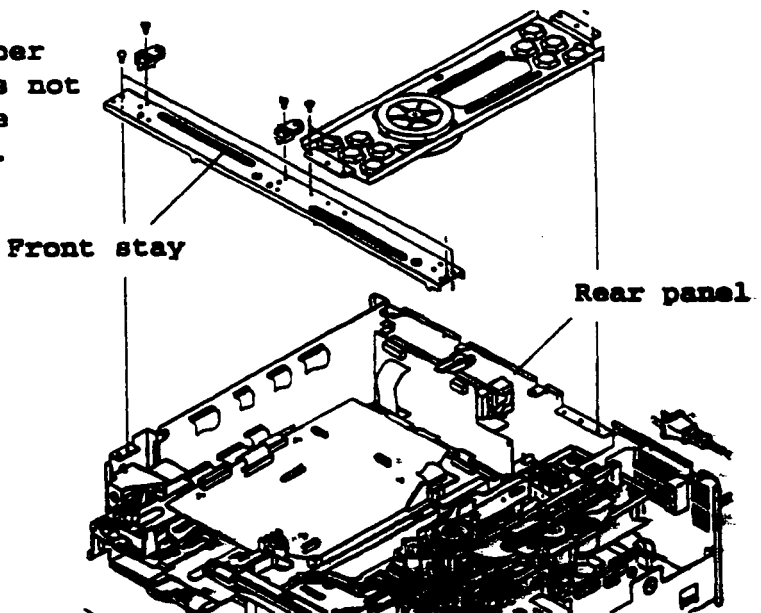
<PROBLEM> Mechanical noise is audible when an LD disc is played.

<CAUSE> When an LD disc is clamped, the motor center axis is slanted due to:

- The height of the mech mounting portions on the Chassis is lower by 0.5mm.
- The mounting position of the mechanism is deviated toward the rear side.

Therefore, the clamber rubs against the clamber arm at the rear side.

1. Stick 1 or 2 spacers (DEC1743) to the mech mounted portions of the chassis. (See Fig. 2) (One spacer has already been stuck there from the 1st production.)
2. If mechanical noise remains after the spacers are stuck, replace the rear panel and the front stay with the new parts (DNA1135 & DNE1207).

Rear panel:	N.S.P.	----	DNA1135
Front stay:	DNE1207	----	DNE1207*
Spacers (x4):	DEC1743	----	Deleted

* Although the part number for the front stay has not been changed, only the new part is available.

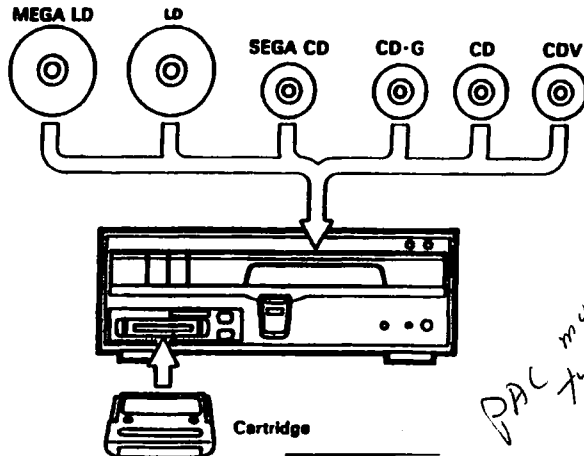
PAC must click twice to be fully seated - keeps w/it come up when properly installed & power on
