Date: February 10, 1997

Model: PVM-14N1U/14N2U/20N1U/20N2U

Video Products Technical Bulletin 1996-165R

Subject: BKM-104 BOARD INSTALLATION

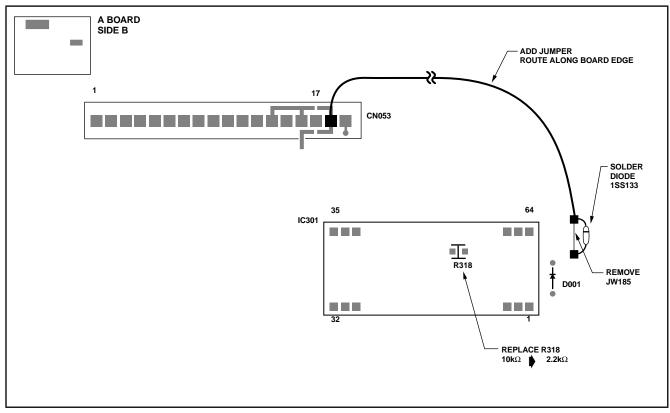
Figure 1

After the BKM-104 caption vision board is installed, CAPTION VISION and the OSD may not display. Due to boards and pin assignments being changed, a short circuit may develop between the display timing signal and ground.

- 1. Remove rear cabinet cover.
- 2. Remove wire soldered to CN053 pin 17 (zone A-4, side B). (See Figure 1.)
- Remove resist and silk print from around CN053 pin 17. Cut traces.
- 4. Solder removed wire, from CN053 pin 17 (step 2), to CN053 pin 13 as shown in Figure 1.
- 5. Remove JW185 and replace with 1SS133 diode. Solder diode, connecting cathode to IC301 side. (See Figure 2.)
- 6. Replace R318 (10k Ω) with 2.2k Ω resistor.
- 7. Solder 250mm wire jumper between the 1SS133 cathode and CN053 pin 17.
