CRT Troubleshooting

Diagnostics and Troubleshooting

Course: CRT-01

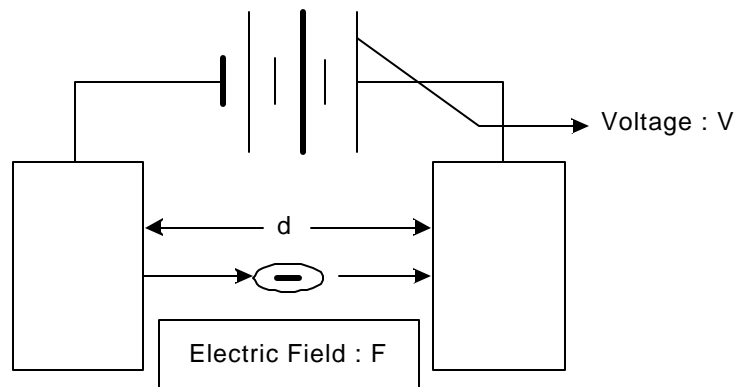
FIGURE 6-3

As a result of cold emissions, electrons flow from a lower electric potential of the gun to a higher potential of the gun in areas that they would not otherwise normally flow.

Cold Emission occurs when an electron flow is induced by a strong electric field between two parallel electrodes.

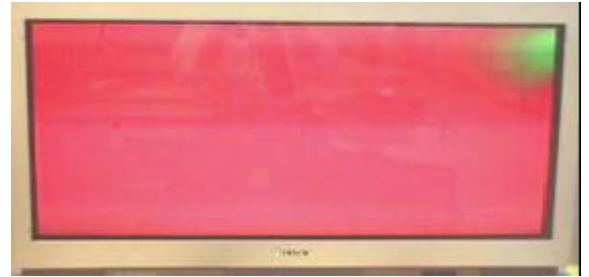
FIGURE 7-1

Poor beam landing is visible as a discoloration whenever there is a raster on the screen. It can be of any size and in any location on the screen. An example is shown in figure 7-1.

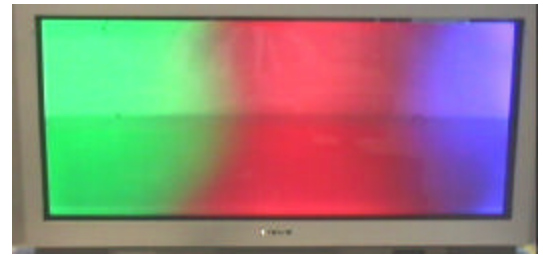
FIGURE 7-6

Check for loose DY, especially If M/L is extreme and concentrated on the right/left sides rather than at corners. See Figure 7-6. If DY is loose, slide DY forward or backward to improve landing and tighten. see Note 2.

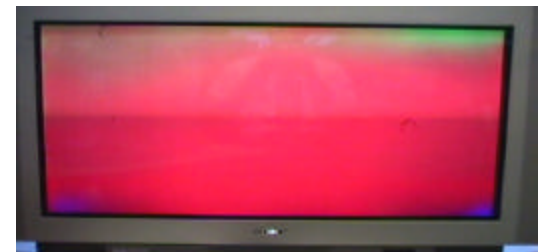
FIGURE 7-8

These can occur in any screen edge or corner. See Figure 7-8.

Remove L/D magnets and replace with new one on the effected corner. Readjust.

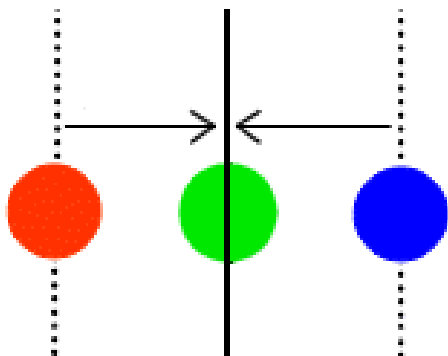
FIGURES 10-5 A & B

Adjust the H-Stat control on the C board to bring the red and blue spots in line with the green.

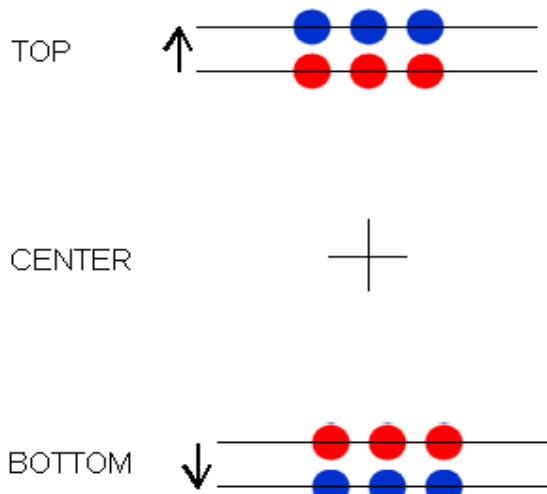
FIGURES 10-6 A & B = LTV REACTOR FUNCTION & LOCATION

Separate the dots (again) with the TLV reactor control on the DY, and adjust the LTV reactor to converge the red and blue dots at the top and the bottom of the screen. See Figure 10-7a. The location of the reactors is shown in Figure 10-7b.

For models with reactor controls, turn the control wheel to correct convergence keystone. Figure 10-7b shows the XCV reactor location. In convergence keystone, the red and blue dots cross vertical positions from side to side. See Figure 10-14

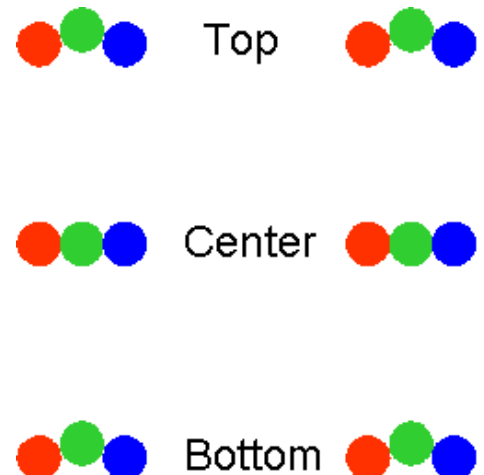
FIGURE 10-8

Ideally, all three color dots should line up in the horizontal axis from the top to the bottom of the screen. If the screen looks like Figure 10-8, make corrections by rotating both 6-pole magnet rings together as a unit. Touch ups with the 4-pole ring magnets may be necessary as the rings interact with each other. Priority must be given to the center areas.

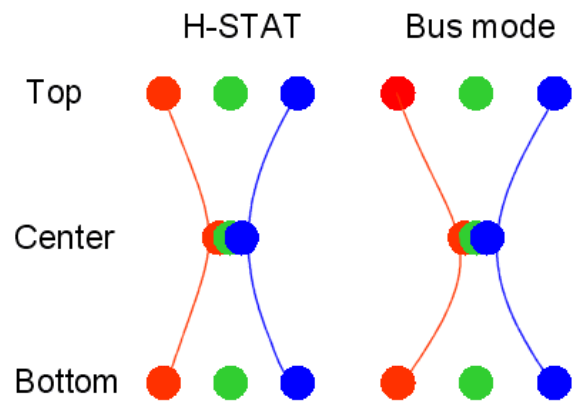
FIGURE 10-9

There are two adjustment methods when the red or blue are bowed but line up on the same side of the green in the vertical plane. See Figure 10-9.

- Use the YBWU and YBWL bus service mode registers on units that have these registers. Many units do not have these registers.
- On models without the YBWU and YBWL registers, make corrections with the H-STAT control.

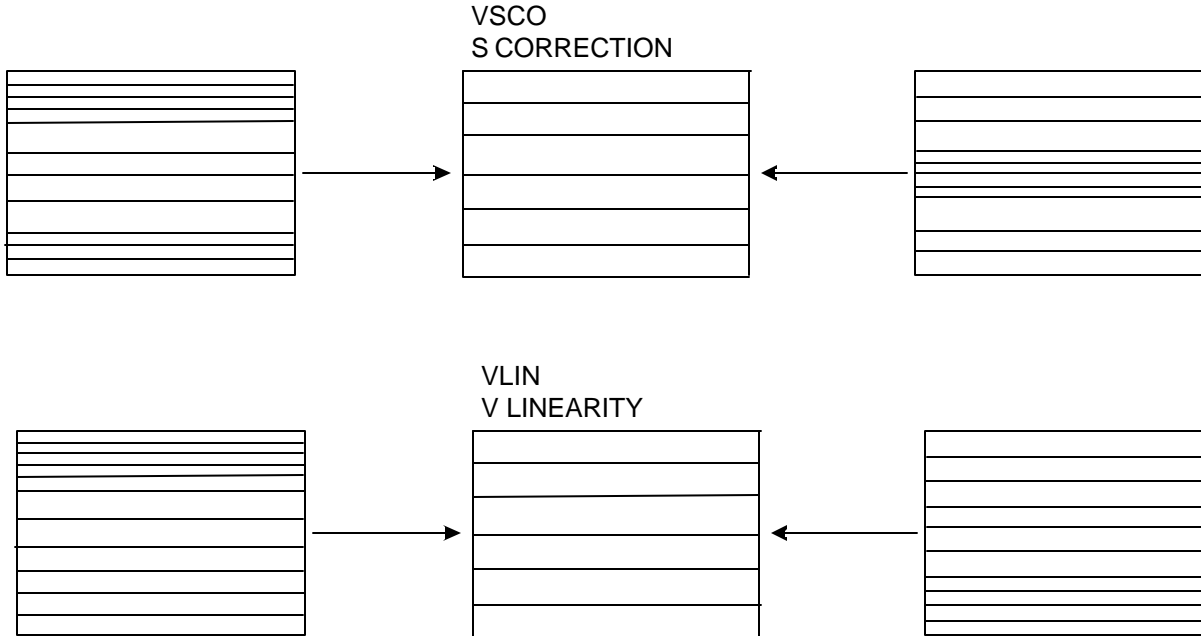
11) Adjust vertical S-Correction and V Linearity so that the height of the squares is the same at the top, center and bottom of the screen using the Bus service mode "VSCO" and "VLIN".

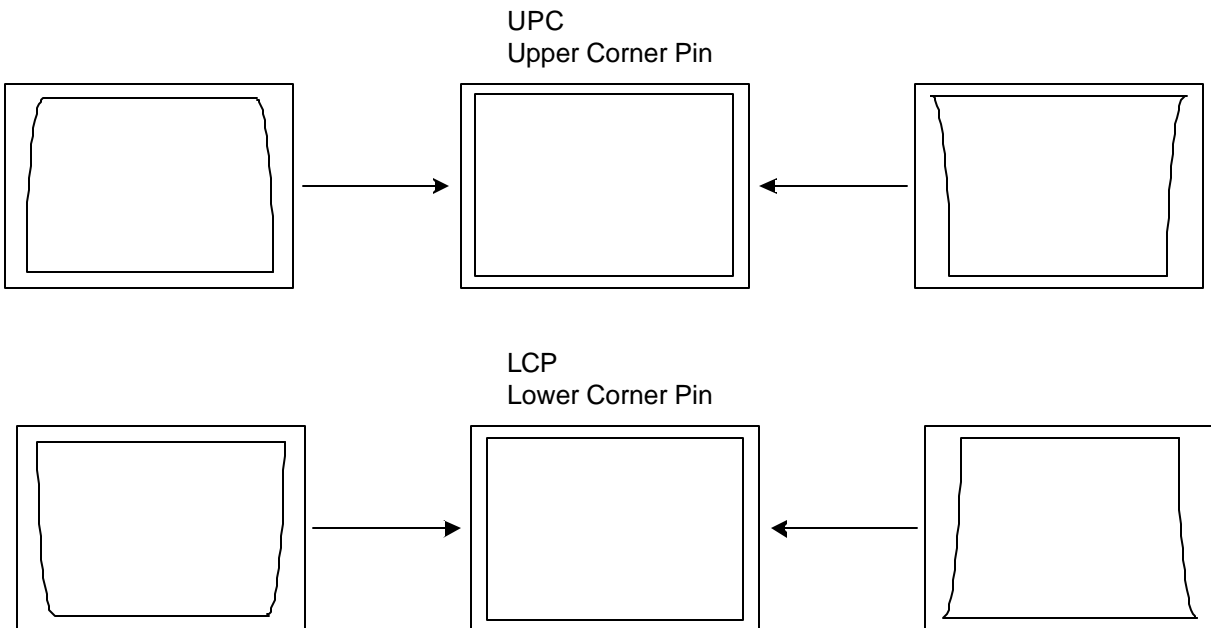
12) Adjust Upper Corner Pin and Lower Corner Pin using the Bus service mode "UCP" and "LCP".
