Video Products Technical Bulletin 30-2008-089

SUBJECT: **PICTURE SHAKES HORIZONTALLY WHEN UNDER-SCANNED**

MODEL: **PVM-14L5**
PVM-20L5
PVM-D14L5A
PVM-D20L5A

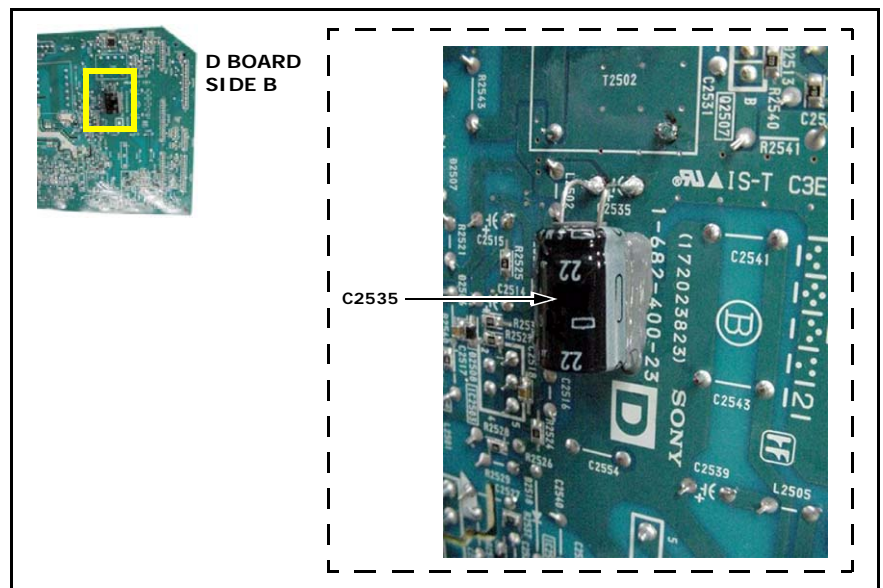
Figure 1

The picture may shake horizontally when under-scanned.

D Board (Side B)

1. Replace C2535 with a new 105° C-type capacitor. (See Figure 1.)
2. Affix the capacitor to the board with RTV.
