Video Products Technical Bulletin 30-2003-003

SUBJECT: **PREVENTING CAPACITOR ON D1 BOARD FROM TOUCHING REAR BRACKET**

MODEL: **PVM-20L5**

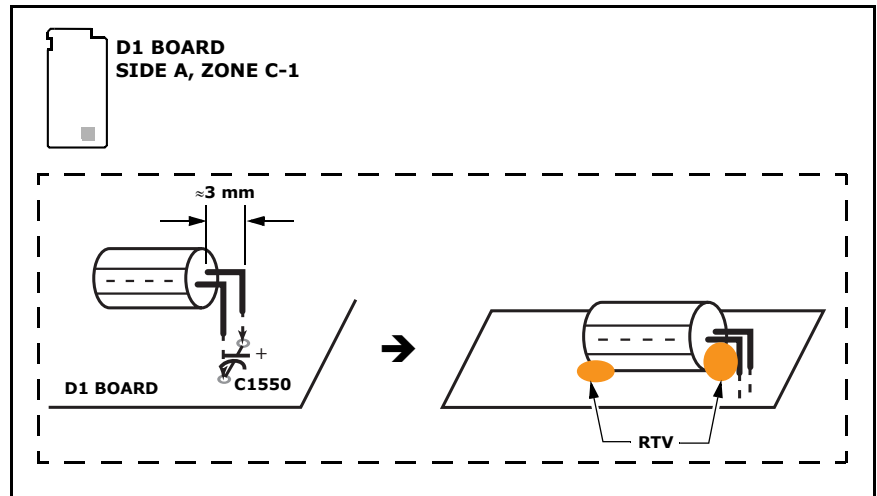
Figure 1

To prevent C1550 on the D1 board from touching the rear bracket, perform the following modification procedure.

D1 Board (Side A, Zone C-1)

1. Replace C1550 with a new 1000 μ F capacitor as shown in Figure 1.
2. Affix the capacitor to the board with RTV.
