Date: **December 21, 1998**

Subject: **OSCILLATION IN HIGH TEMPERATURES**

Model: **BVM-14E1U, BVM-14E5U, BVM-14F1U**
BVM-14F5U, BVM-20E1U, BVM-20F1U

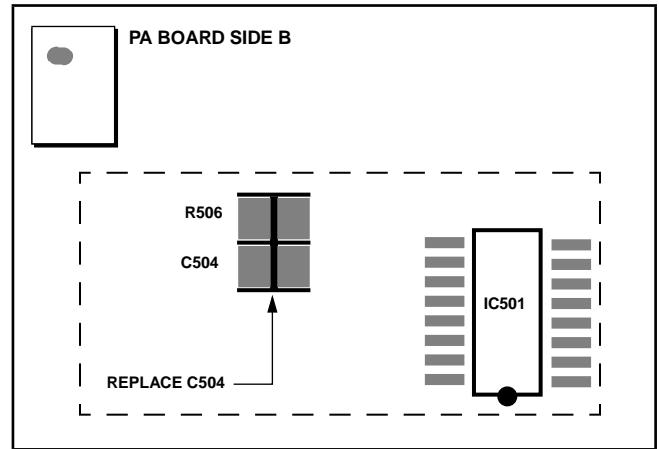
Figure 1

When units are operated in high temperature environments, such as rack-mounted, horizontal noise may occur if unit becomes too hot. Replace capacitor C504 on the PA board, side B with improved one.

Part No.	Description	Qty.
1-164-690-11	Capacitor, 2200pF	1
