Subject: **CORRECTION OF INTERRUPTED
 CIRCUIT**

Model: **BVM-1915**

Serial No: **2,000,231 AND HIGHER**

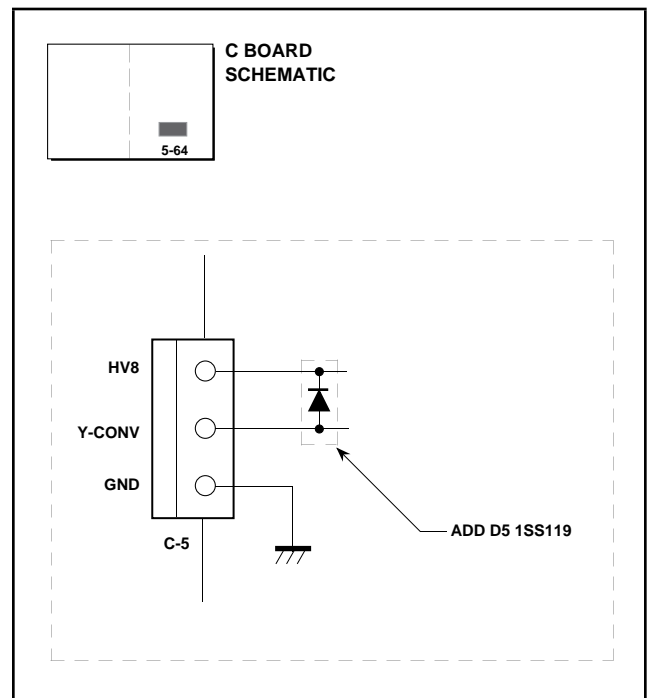
Figure 1

IC14 and Q2 on the DA board may fail due to electrical discharge of the high voltage current. To correct this, add diode D5 1SS119 to the C board as shown in Figure 1.

NOTE: The mounting location for D5 is already printed on the C board.
