Date: **October 4, 1993**

Subject: **NEW EXTERNAL POWER JACK**

Model: **PVM-8020**

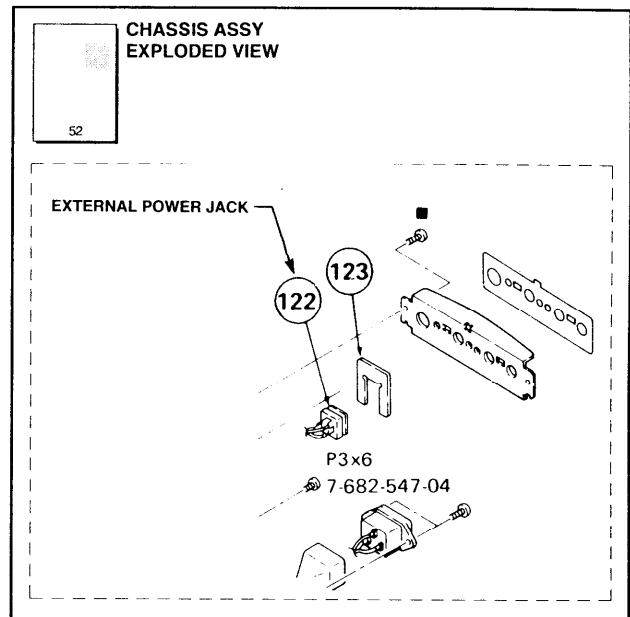
Figure 1

If a battery other than an BP-90 or BP90A is used, the positive side terminal of the external power jack may contact the chassis, thereby causing excessive current to flow from the battery.

To prevent this from occurring, replace the external power jack with the high-shock resistant one and add insulation tape to the bottom of the jack to isolate it from the FB block.
