Broadcast Products Technical Bulletin 20-2003-091

SUBJECT: **PICTURE DISTURBANCE AND GREEN PICTURE**

MODEL: **BKM-21D**

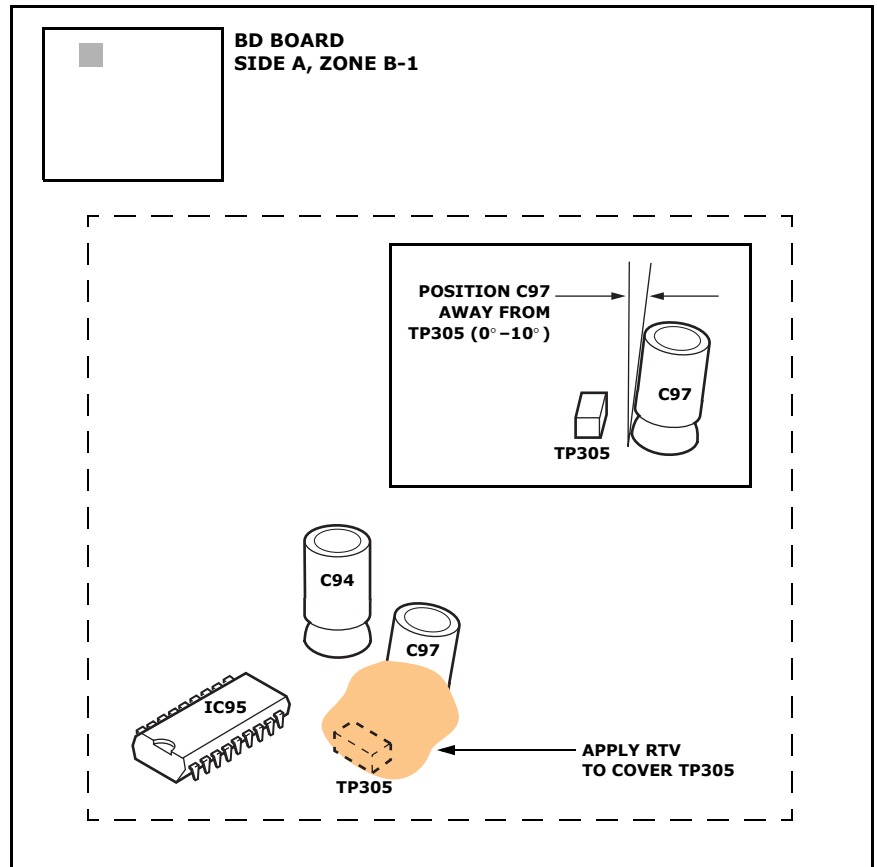
Figure 1

If C97 comes into contact with TP305, severe picture disturbance may occur and the picture may turn green.

BD Board (Side A, Zone B-1)

Remove TP305 if it is mounted,
or

(See Figure 1.)

Use RTV to hold C97 away from TP305 as follows:

1. Reposition C97 perpendicular to the board or approximately 10° away from TP305.
2. Apply RTV to C97 and TP305 as shown in Figure 1.
