# Broadcast Products Technical Bulletin 20-2003-271

SUBJECT: **NO PICTURE**

MODEL: **BKM-41HD/1  
BKM-42HD/1  
BKM-142HD**

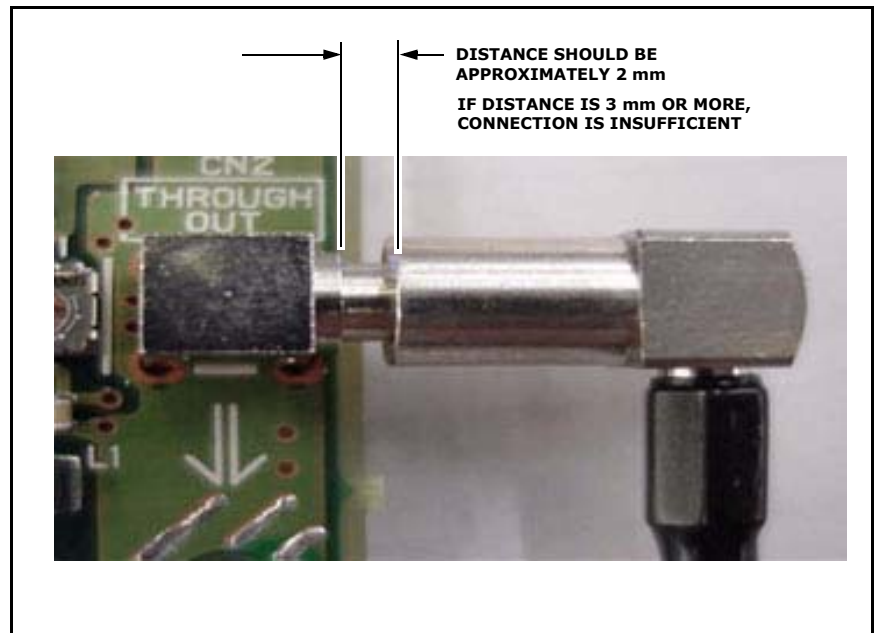
**Figure 1**

If there is no picture with HD-SDI input or from MONITOR OUT, the coaxial cable connector may not be completely connected.

Model	Location	Qty
BKM-41HD	SDI assembly	2
BKM-42HD	SDI assembly	4
BKM-142HD	CN405 (BHA board)	1
BKM-142HD	BHB board	2

When the coaxial cable is disconnected during repair or periodic maintenance, ensure that the connector is reconnected firmly, until it locks with a clicking sound. (See Figure 1.)
